State of Nevada
Department of Corrections
Jean Conservation Camp
Facility Condition Analysis

JEAN CONSERVATION CAMP

Site Number: 9892
STATE OF NEVADA PUBLIC WORKS DIVISION
FACILITY CONDITION ANALYSIS

Report Printed in February 2012

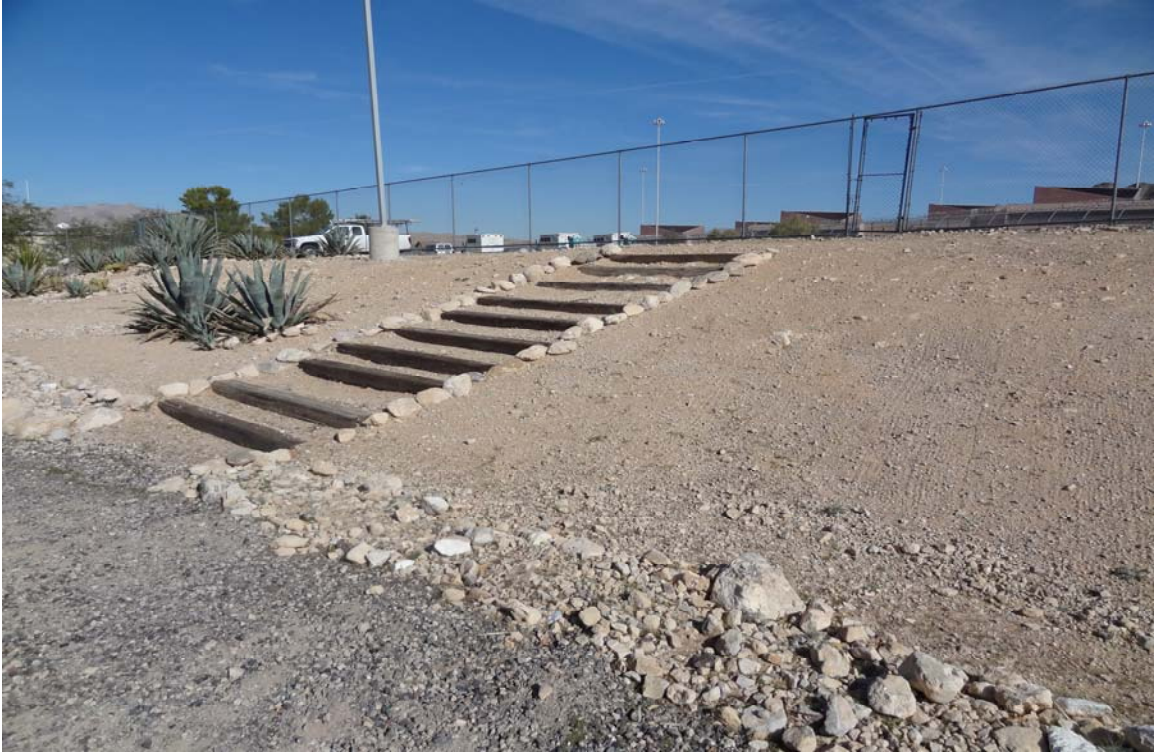
The concrete exterior stairs leading from the Visitors parking area to the MPR/ Visitation Building are lacking handrails as required in the 2006 IBC Chapter 10, Section 1012. There are also a stairway constructed with railroad ties which is also lacking handrails and are not to current building codes. This project would provide for a tubular steel framed handrail to be installed on both sets of stairs. This project recommends reconstructing the railroad tie stairs to meet current building codes or eliminating them. The construction cost includes handrails and new stairs.

Jean Conservation Camp Site - Site #9892
Description: Non-code compliant stairs from upper parking area.

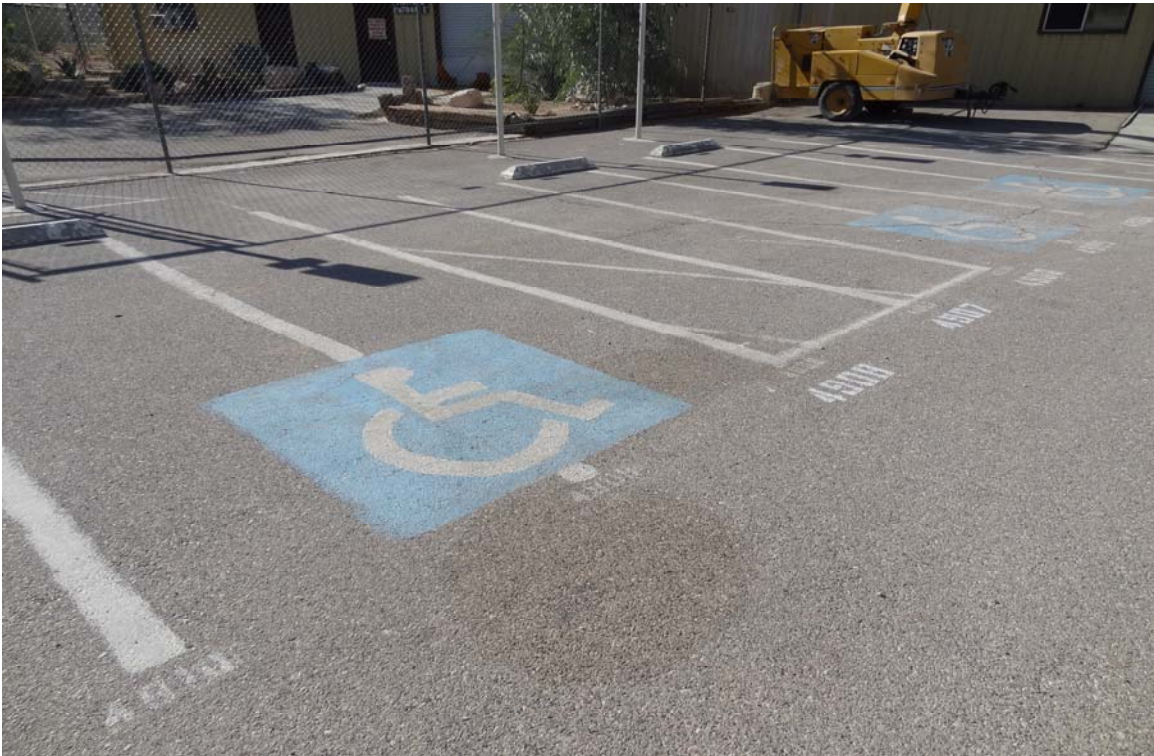
The upper level visitor parking is partially paved, not striped and in poor condition. ADA accessible parking for visitors is located in the lower level parking area and is in fair condition but the striping and signage is not fully compliant.

Jean Conservation Camp Site - Site #9892
Description: ADA parking in lower parking area.

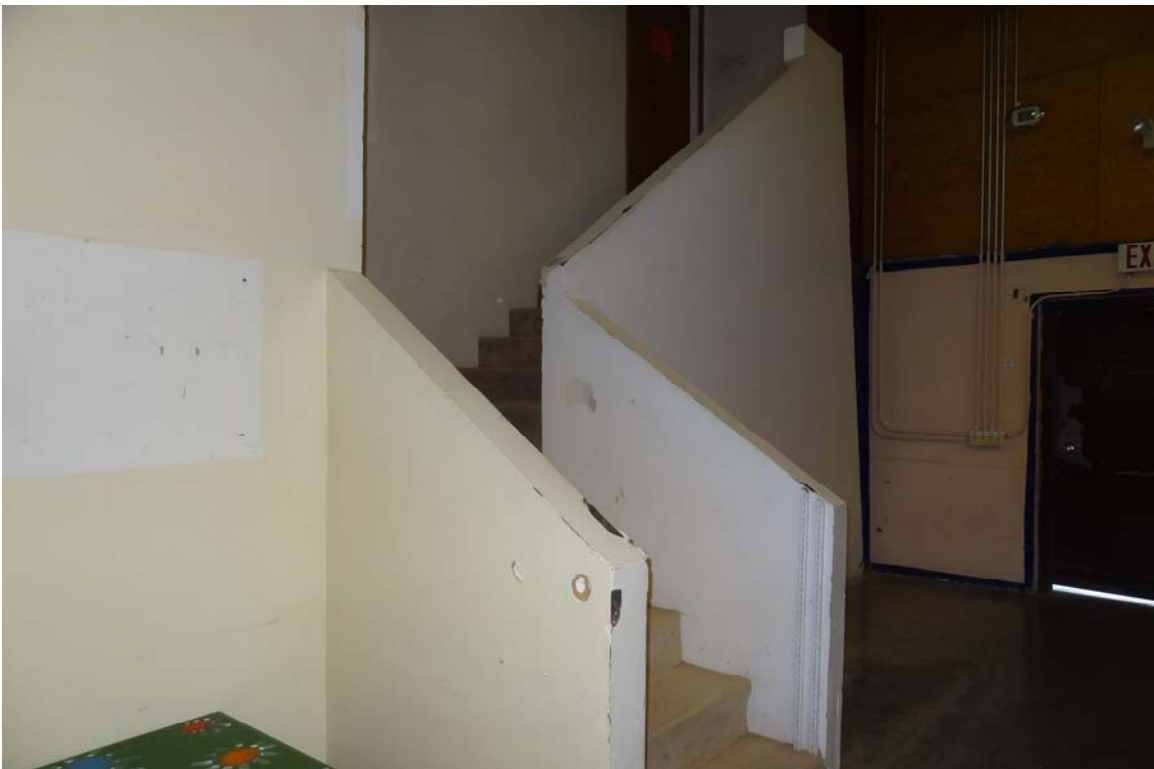
The two sets of stairs and handrails between the first floor and the second floor do not meet the requirements in the 2006 International Building Code sections 1009 and 1012. The stairs do not have the correct rise and run, one stairway is less than 44" wide and they are either missing handrails altogether or have handrails that do not meet code. This project would provide funding to remove and replace the stairways and handrails.

MPR / Visitation - Building #1898
Description: Non-code compliant stairs to classroom area.

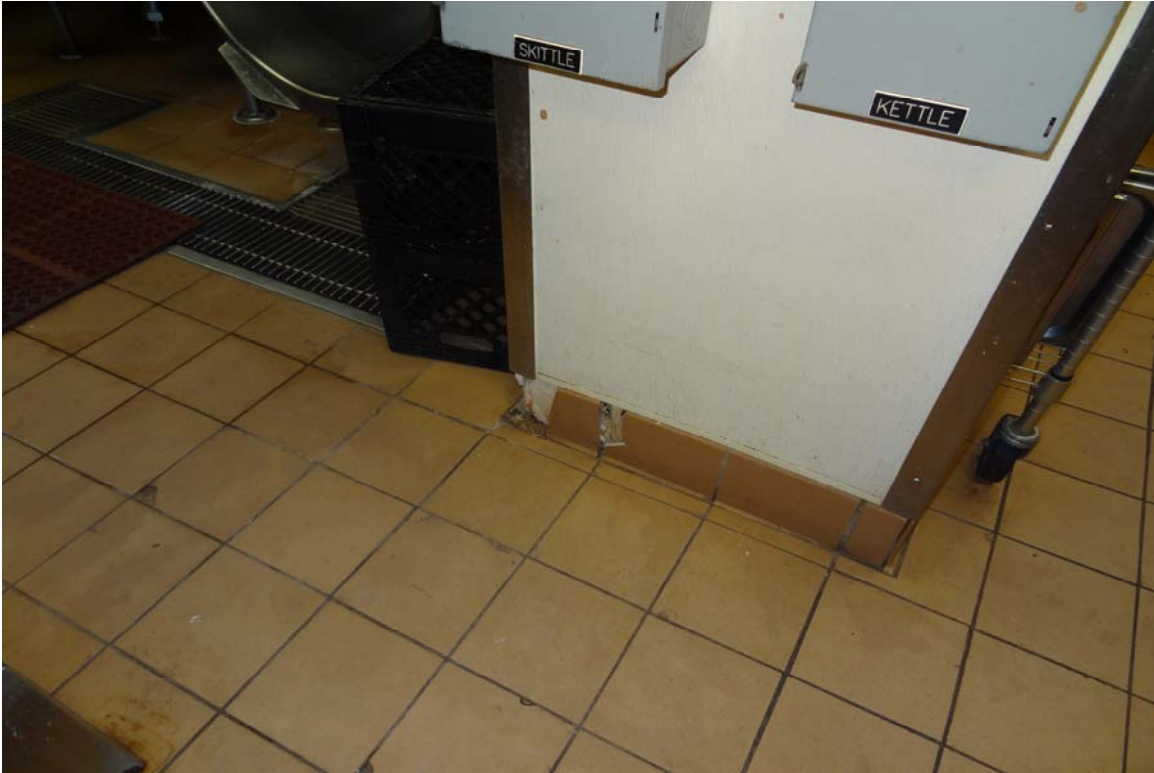
Culinary / Canteen / Dining Hall - Building #2125
Description: Tile base damage in Culinary area.
